# **EAST FORK OF ROCK CREEK DAM**

## **Fact Sheet**

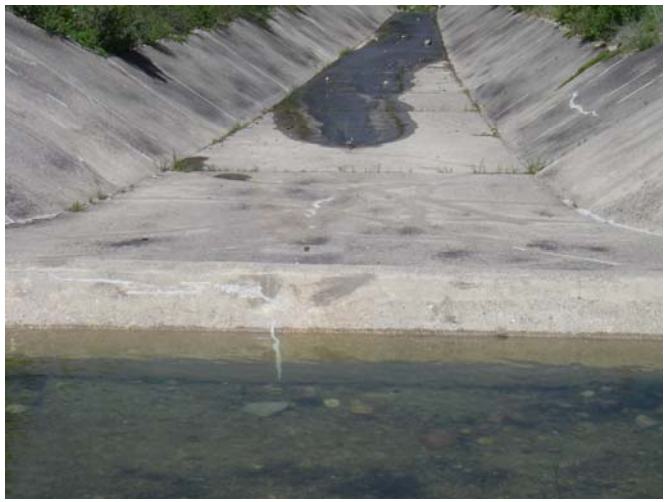
Spillway

- ♦ The spillway is in poor condition and does not meet current safety standards. Replacement is needed due to concrete deterioration from age and insufficient spillway capacity.
- ♦ Excessive seepage may require the installation of additional drains or relief wells.

- ♦ Construct a new spillway that meets or exceeds current safety standards.
- ♦ Investigate the need for additional seepage collection and drains. Install additional drains and seepage collection if needed.
